DEALING WITH DOMESTIC OIL SPILLS

Case Study – New Reported Oil Spill –

New Year's Eve 2005 Petawawa, Ontario

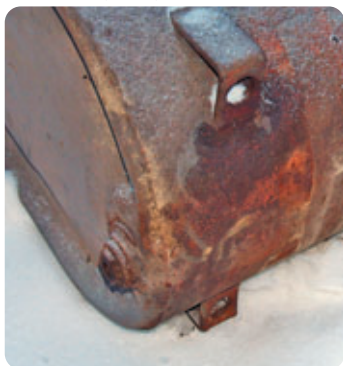
Oil tank clearly showing hole.

Oil has traditionally been stored in thin walled 14-gauge steel tanks, situated either in the homeowner's basement or on the exterior of their homes. These tanks usually have a warranty lifespan of 3 to 6 years after which, the tanks should be replaced. Considerable rusting and corrosion starts very early in the lifespan of the average steel tank and usually occurs from the inside out.

Homeowners need to be aware of this situation when they are upgrading/replacing their tanks and consider purchasing a 12-gauge tank which has a thicker wall and utilizing some of the new more efficient products which are now available. These tanks usually have a safe 10 year life span.

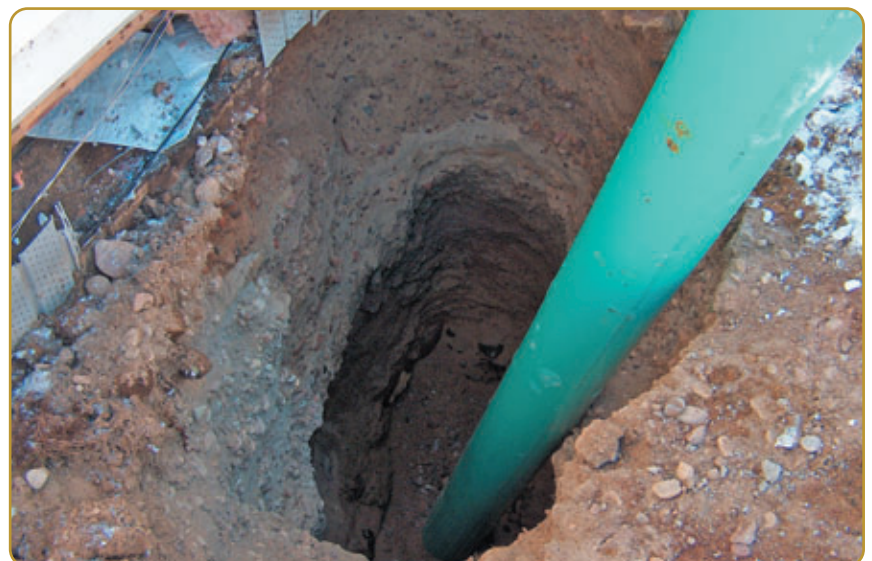
As per procedure, technicians pumped the tank dry and removed it. An oil spot about 6" in diameter was identified so they immediately dug a 10" deep trench around it to contain the spill and put in a containment boom with inside surface oil containment pads.

The test pit where the hole was dug directly under the location of the leak from the oil tank.

The initial site examination indicated almost no free product or heavy residue on the surface soils and no surface staining beyond 60 inches of the actual point of release. Since this oil spill took place in Petawawa, they knew the soil type was a sandy soil and there was a clear indication that the heating oil went straight down aided either by lack of frost or sandy soils.

The next day Dean Fuisz, owner of PDS of Renfrew County next contacted an environmental clean-up contractor, who was on-site by early morning. A Test Hole at the spill site was drilled 11 feet deep and samples taken indicated the presence of hydrocarbons.

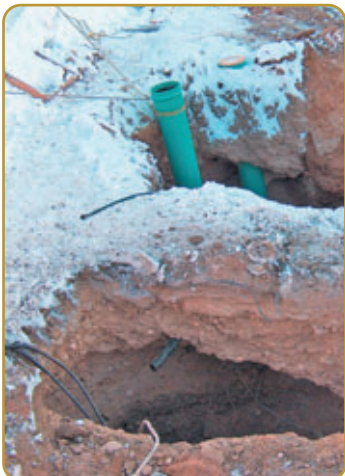
Testing wells were dug all around the property and all but one indicated the presence of hydrocarbons. In this case the mobile home was totally removed, perimeter fencing was put in place and the entire area was excavated. Soil was removed to an 18 foot depth which was taken to a landfill site and this property area was replaced with infill. There was also on-site water treatment whereby the standing water was pumped into a container and separated from the oil.

Well testing for oil.

Although the PDS portion of the job is complete, outside perimeter wells are still being tested on a periodic basis for hydrocarbons by the insurer. TSSA is still investigating the site and charges may be placed against the different parties involved.

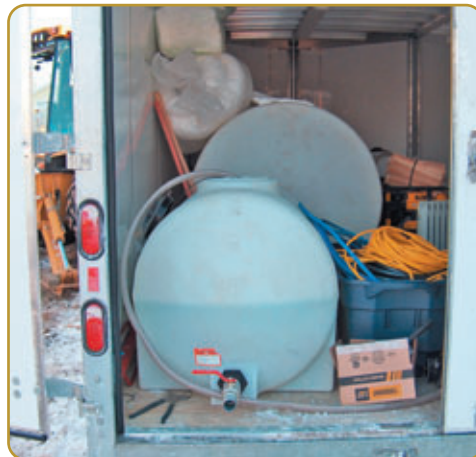
On-site water treatment where the standing water is separated from the oil.
